Technical Service Bulletin

RMI-TSB-001-20161201

Air Restriction Sensor for Kohler APUs

KL3-001K Air Restriction Sensor for Kohler LG200 & T4-6 (with or without heat)

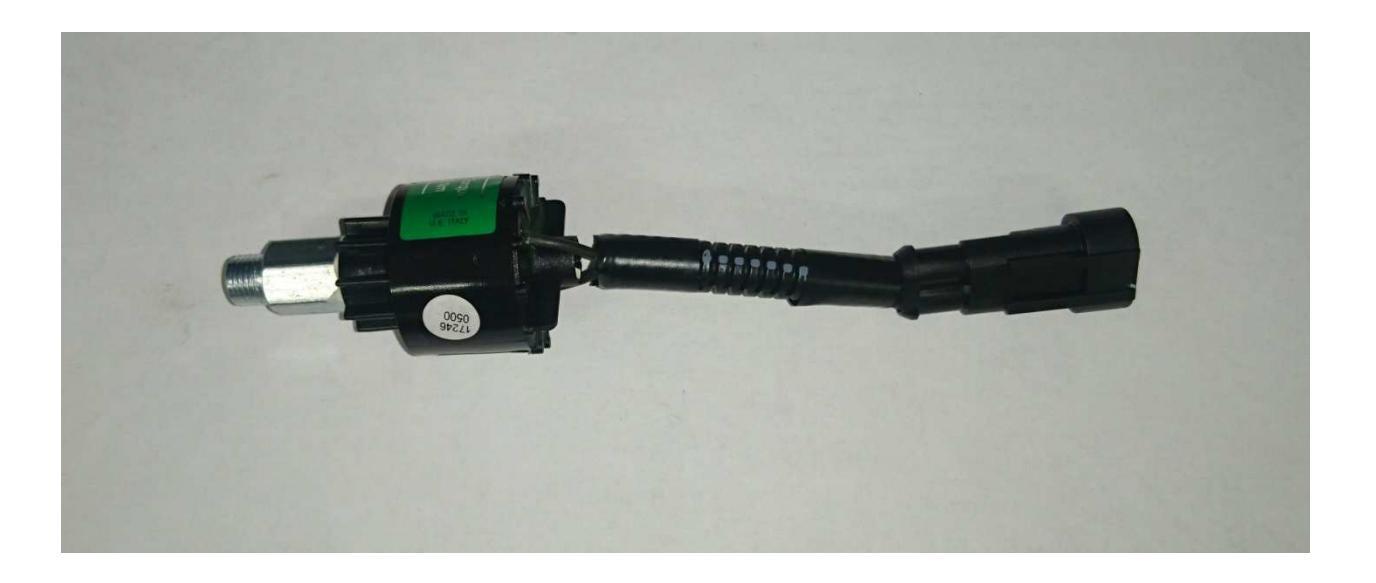
The Air Restriction Sensor has been introduced to protect the APU engine from poor air flow due to blockage of the air intake system. The Air Restriction Sensor checks the air flow through the intake system of the APU. If there is an obstruction that limits the air flow, the APU will shut down and an error message will appear alerting the operator to check the air flow quality of the APU.

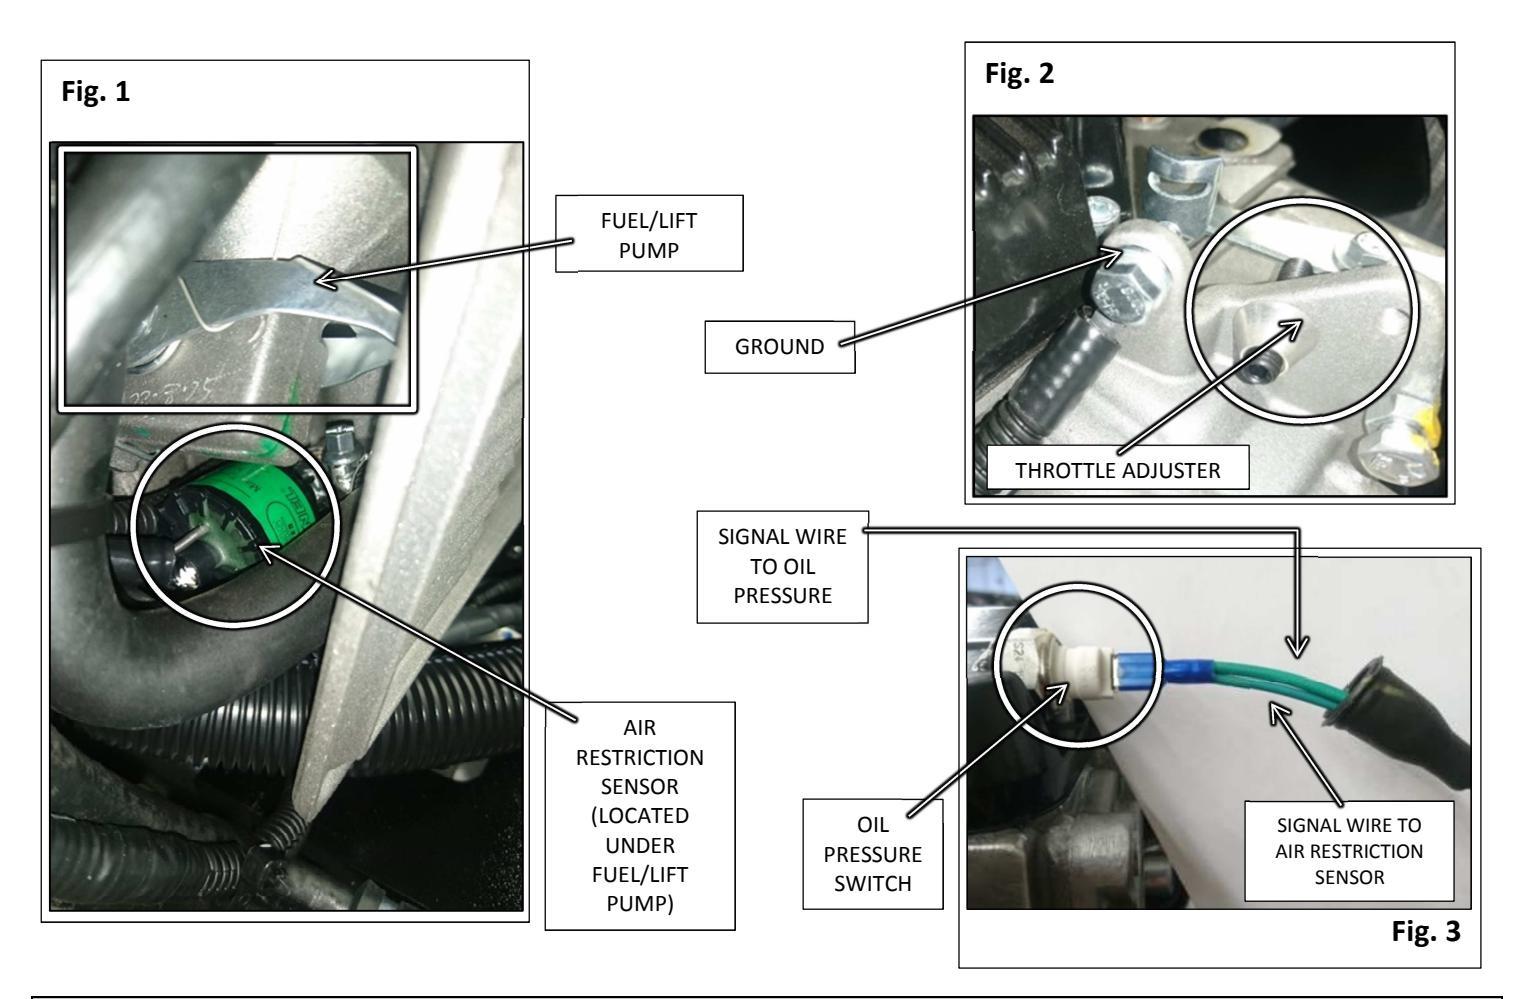
If this code is displayed, check Air filter to see if it need replacing first. If the Air Filter is clean, check the Oil Level Sensor wiring or Engine Oil Level to see if this is the cause. If the code is still present, check the wiring diagram for power and ground on correct wires. If error persists, unplugging the Air Restriction Sensor from the harness will render the sensor inactive.
